# PHASE I ENVIRONMENTAL SITE ASSESSMENT THE PRESERVE SACRAMENTO COUNTY APNS 072-0300-001, -002, -005, -008, -010 and 073-0010-011 RANCHO CORDOVA, CALIFORNIA

Subject: THE PRESERVE

Grant Line Road & Raymer Way, Rancho Cordova, California

Phase I Environmental Site Assessment

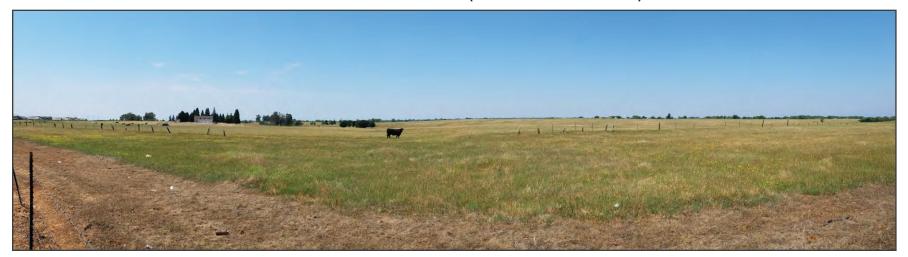
Photo 1: Photo of the south portion of parcel 073-0010-011 from Raymer Way.

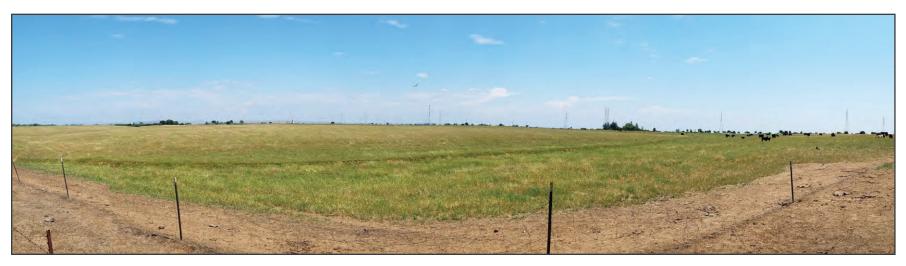
Photo 2: Photo of the south west area of parcel 073-0010-011 from the Divine property viewing east.

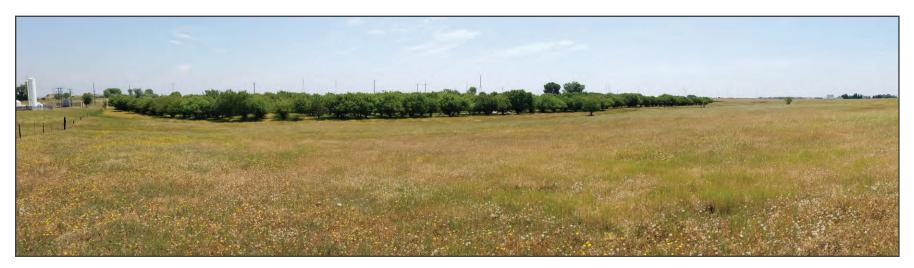
**Photo 3:** Photo from the northeast corner of parcel 073-0010-011. The olive orchard is visible to the left. A Siemens pump station and substation in the north adjacent property are visible to the left.

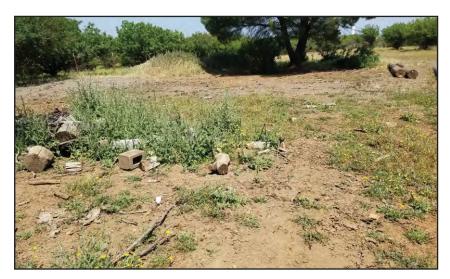
**Photo 4:** Debris was observed in the area where a residence once stood.
